## Home Inspection Report

**1064 Durham Court, Sunnyvale**

**Inspected by:**    
Andrew Amon  
April 11, 2024

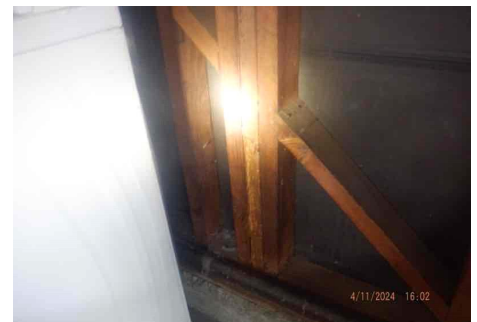
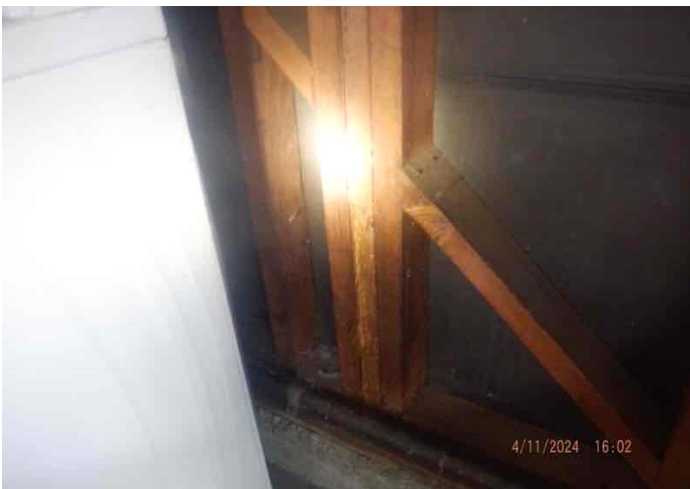
Photo 15

1. The wall framing of the right side of the garage shows evidence of damage. We recommend the advice and services of a licensed structural pest control operator. (See Photo 15)

- ! 1. The wall framing of the right side of the garage shows evidence of damage. We recommend the advice and services of a licensed structural pest control operator. (See Photo 15)

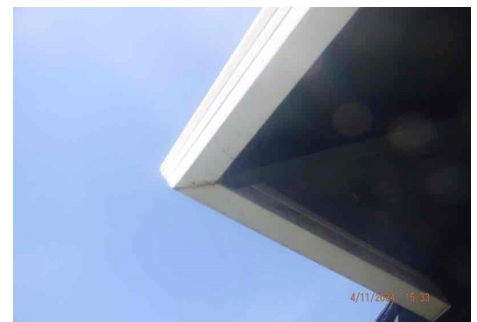
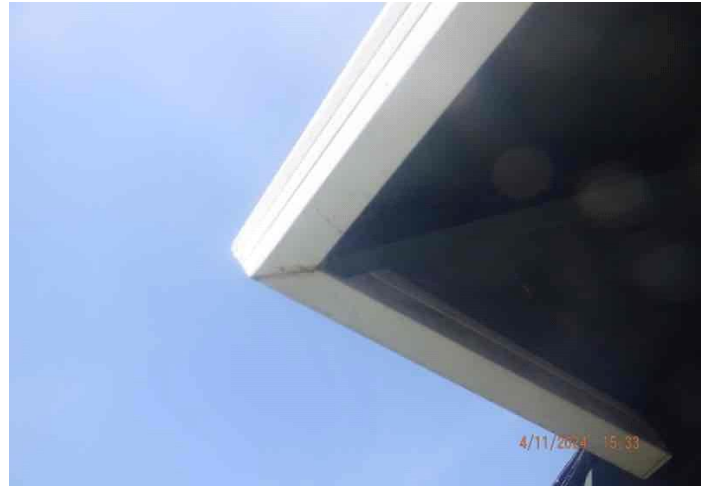
Photo 02

2. Leaks were noted in the downspouts and/or gutters at the seams. During wet weather conditions these areas are more obvious and during dry weather conditions they are noted from the stains at the areas where the leaks have occurred. We recommend all leaks be repaired. (See Illustration 2D) (See Photo 2)

- ! 1. Leaks were noted in the downspouts and/or gutters at the seams. During wet weather conditions these areas are more obvious and during dry weather conditions they are noted from the stains at the areas where the leaks have occurred. We recommend all leaks be repaired. (See Illustration 2D) (See Photo 2)

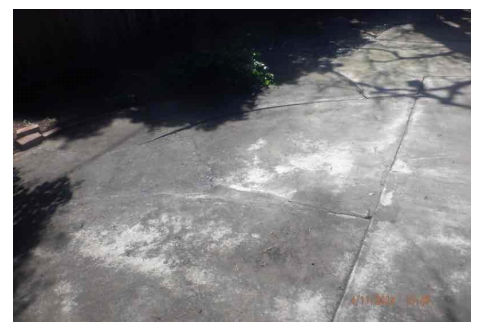
Photo 13

3. The cracked and heaved section of the patio presents a trip hazard. This condition should be corrected for improved safety. (See Photo 13)

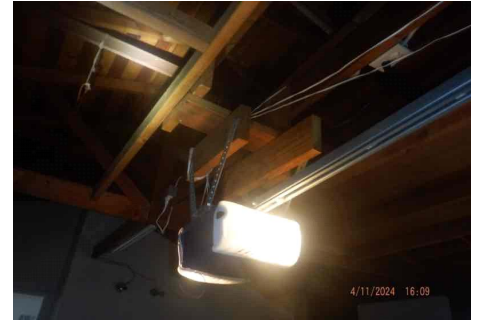
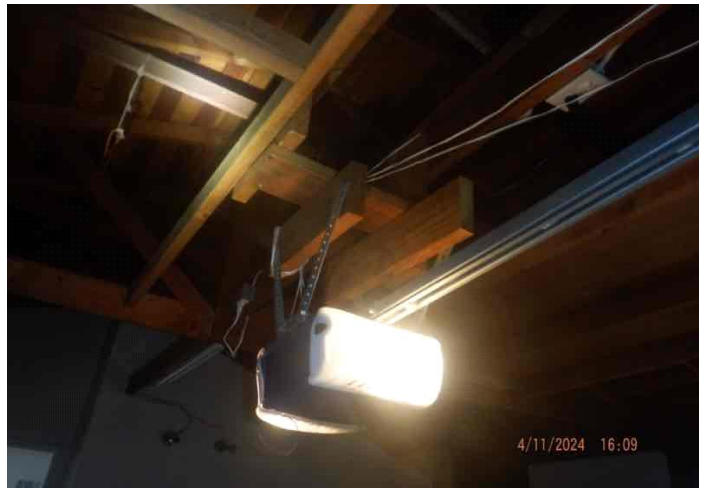
Photo 22

4. The garage door opener appears to be serviceable, but it is mounted in a substandard way. We recommend improving the mounting and bracing of the device to prevent damage to the mechanism and/or door. (See Photo 22)

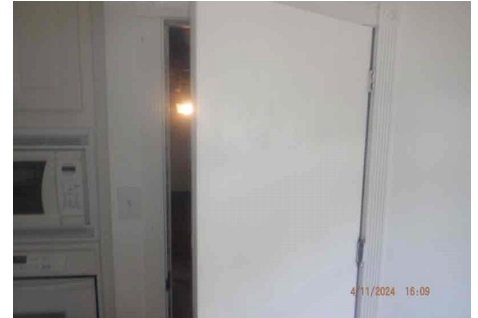
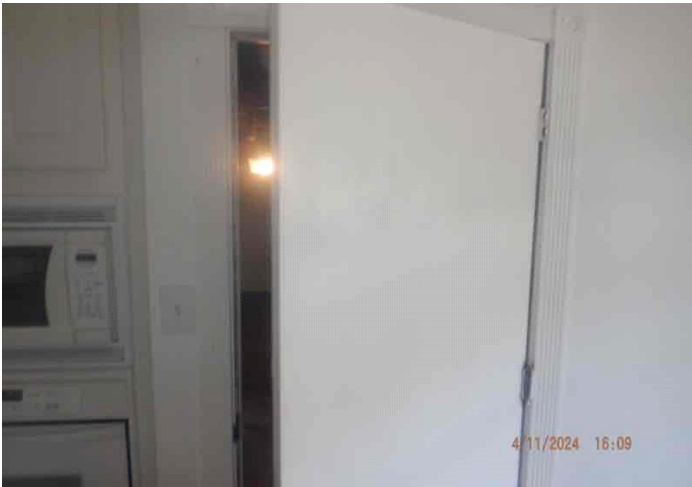
Photo 23

5. The auto door closer between the garage and the house did not function properly. The auto closer mechanism on the passage door between the garage and the interior of the house should be adjusted or repaired to close automatically. This will reduce the potential of toxic automobile gases entering the house and serves as a fire break. (See Illustration 3F) (See Photo 23)

- ! 3. The auto door closer between the garage and the house did not function properly. The auto closer mechanism on the passage door between the garage and the interior of the house should be adjusted or repaired to close automatically. This will reduce the potential of toxic automobile gases entering the house and serves as a fire break. (See Illustration 3F) (See Photo 23)

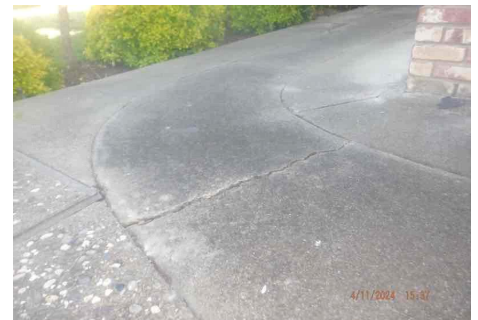
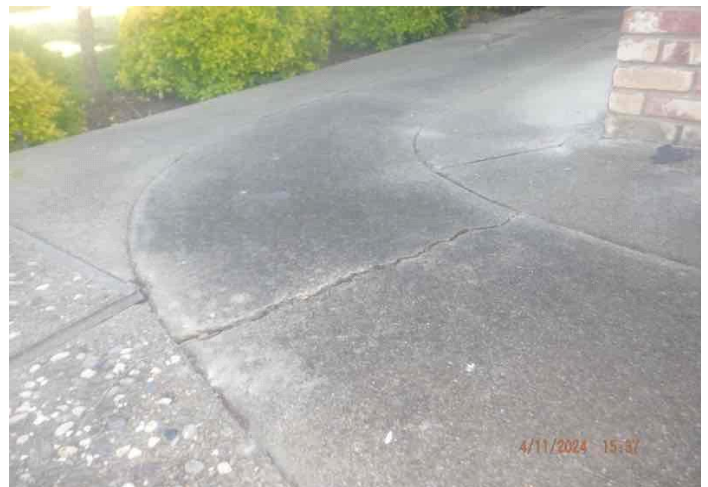
Photo 04

6. The cracked and heaved walkway section(s) at the front left side present a trip hazard. This condition should be corrected for improved safety. (See Photo 4)

- ! 4. The cracked and heaved walkway section(s) at the front left side present a trip hazard. This condition should be corrected for improved safety. (See Photo 4)

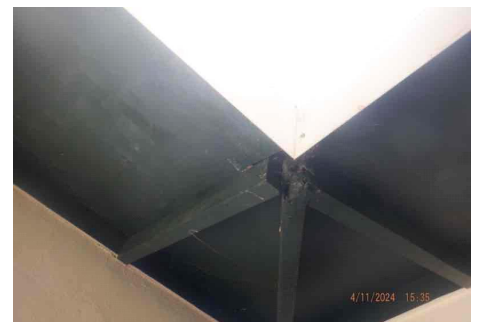
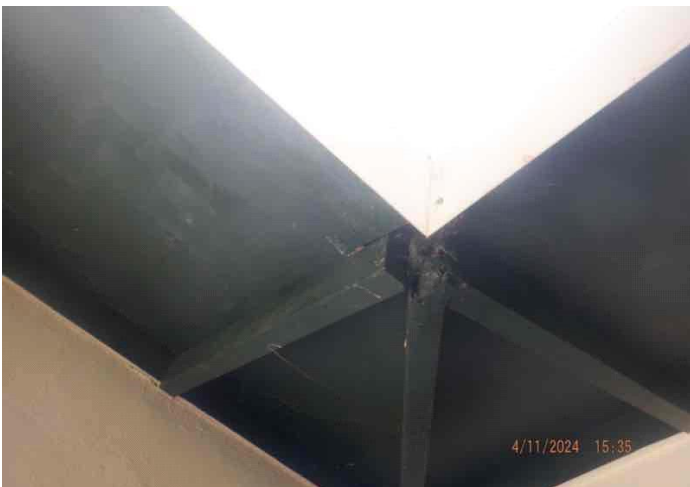
Photo 03

7. Water damage was observed to the rafters/sheathing at the front. We recommend the services of a licensed general contractor and/or structural pest control company. (See Photo 3)

- ! 5. Water damage was observed to the rafters/sheathing at the front. We recommend the services of a licensed general contractor and/or structural pest control company. (See Photo 3)

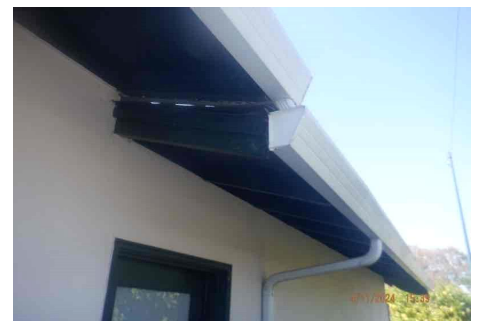
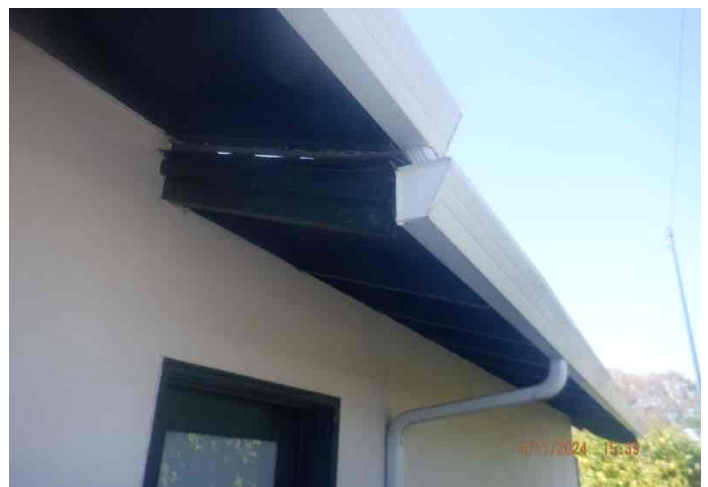
Photo 06

8. Water damage was observed to the rafters at the left side. We recommend the services of a licensed general contractor and/or structural pest control company. (See Photo 6) (See Photo 12)

- ! 6. Water damage was observed to the rafters at the left side. We recommend the services of a licensed general contractor and/or structural pest control company. (See Photo 6) (See Photo 12)

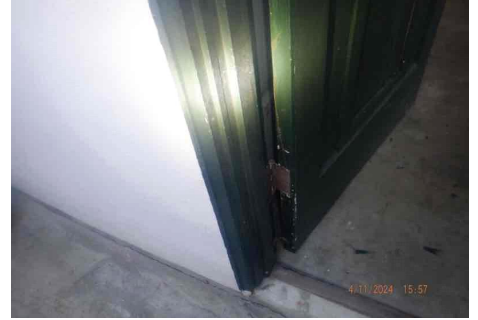
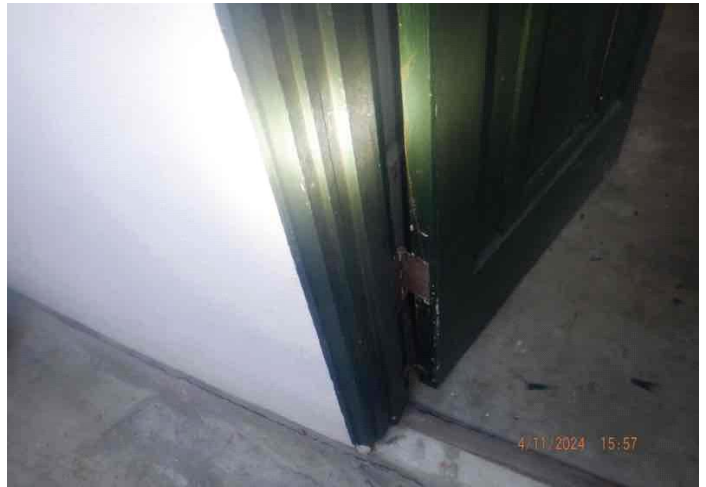
Photo 14

9. The door is cracked, split or damaged at the garage man door. We recommend it be repaired or replaced. (See Photo 14)

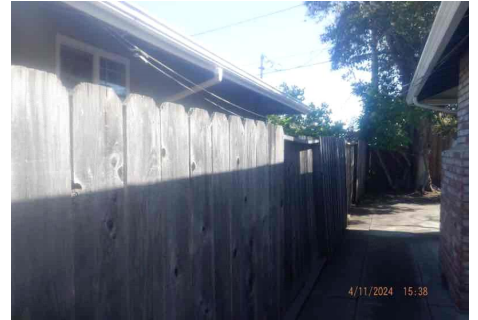
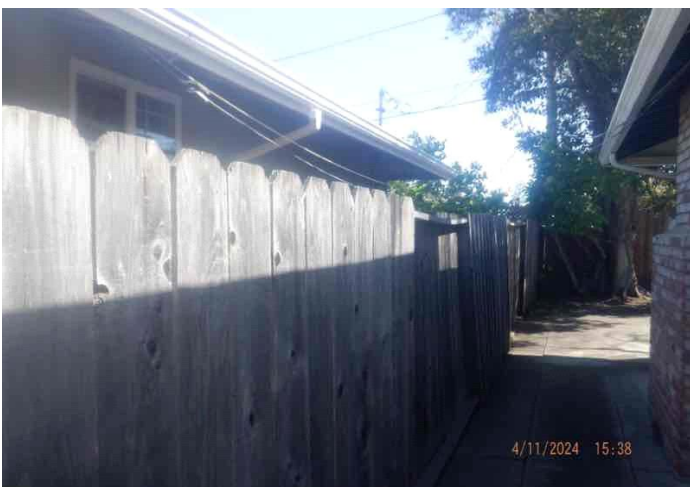
Photo 05

10. The fence is in satisfactory condition, however one or more fence posts are loose at the left side. We recommend all loose, damaged or deteriorated posts be reinforced or replaced as necessary. (See Photo 5)

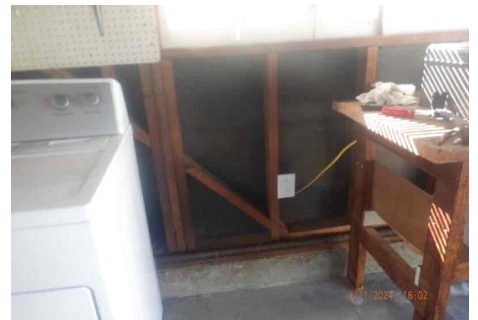
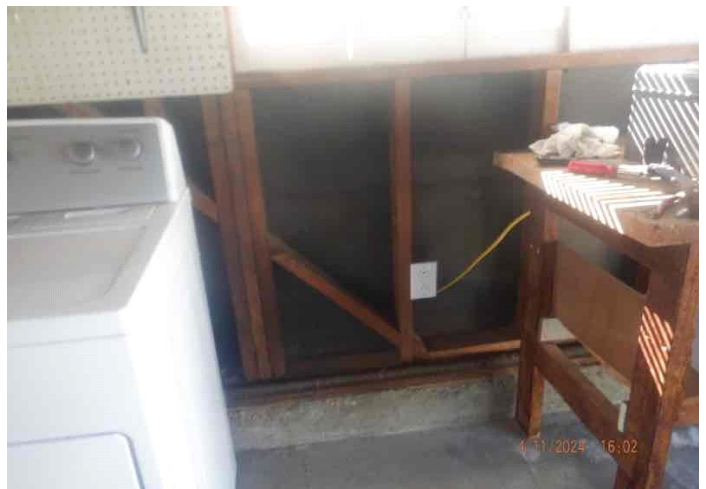
Photo 16

11. We found exposed wiring at the garage walls below 7' feet. Even if insulated, we recommend all wiring be encased in conduit or otherwise protected in accordance with present standards. (See Illustration 4E) (See Photo 16)

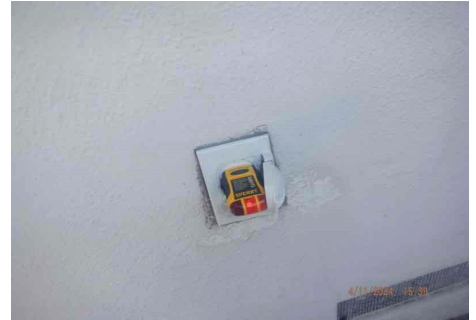
Photo 07

14. Ungrounded "3-prong" outlets at the exterior and interior should be improved. A grounded cable or ground wire could be installed at these outlets, the outlet labeled as ungrounded or the original "2-prong" receptacle could be reinstalled. Based upon our inspection of a representative number of outlets, we recommend testing of every outlet. Repairs or rewiring are recommended at all deficient locations. For additional information we recommend a licensed electrician be consulted. (See Illustration 4O) (See Photo 7)

- ! 4. Ungrounded "3-prong" outlets at the exterior and interior should be improved. A grounded cable or ground wire could be installed at these outlets, the outlet labeled as ungrounded or the original "2-prong" receptacle could be reinstalled. Based upon our inspection of a representative number of outlets, we recommend testing of every outlet. Repairs or rewiring are recommended at all deficient locations. For additional information we recommend a licensed electrician be consulted. (See Illustration 4O) (See Photo 7)

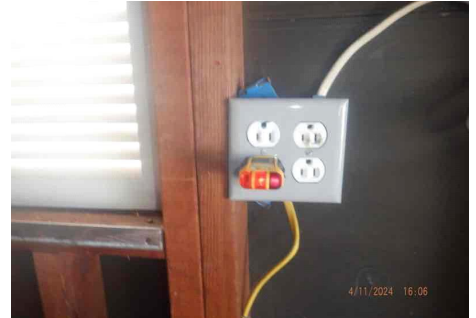
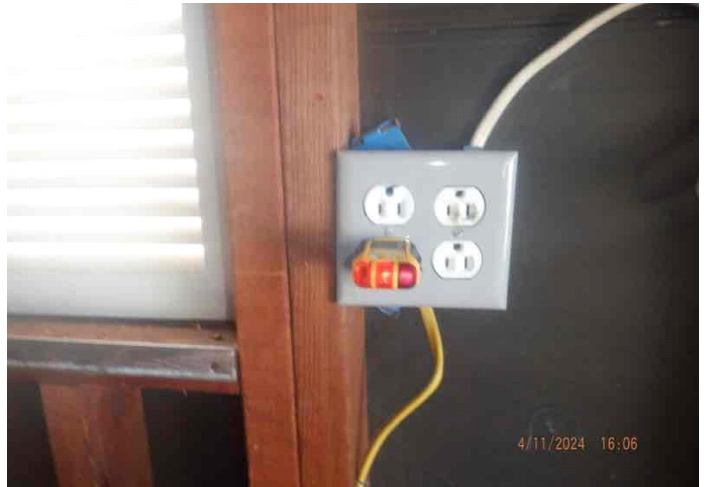
Photo 20

15. One or more outlets at the right side of the garage have reversed polarity, i.e. the hot and neutral connection inside the outlet are wired backwards. These outlets and the circuit should be investigated and corrected. Based upon our inspection of a representative number of outlets, we recommend testing of every outlet at a later date. Repairs or rewiring are recommended at all deficient locations. (See Illustration 4M) (See Photo 20)

- ! 5. One or more outlets at the right side of the garage have reversed polarity, i.e. the hot and neutral connection inside the outlet are wired backwards. These outlets and the circuit should be investigated and corrected. Based upon our inspection of a representative number of outlets, we recommend testing of every outlet at a later date. Repairs or rewiring are recommended at all deficient locations. (See Illustration 4M) (See Photo 20)

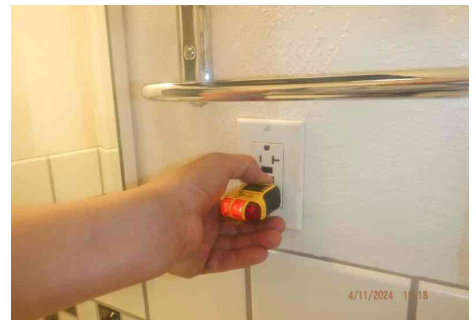
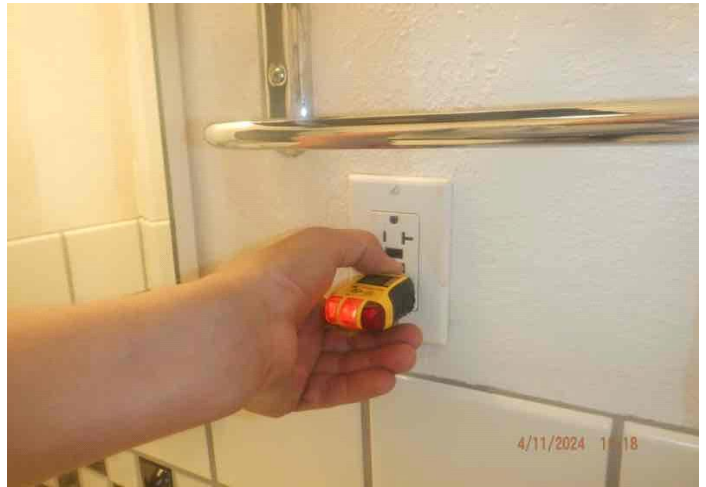
Photo 26

16. A ground fault circuit interrupter (GFCI) outlet at the hall bathroom did not function or did not trip when tested with an outside source and/or the test button. This outlet and circuit should be investigated and repaired. (See Photo 26)

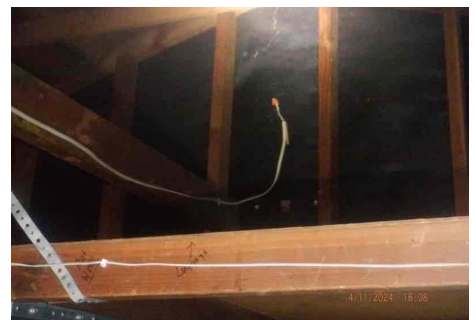
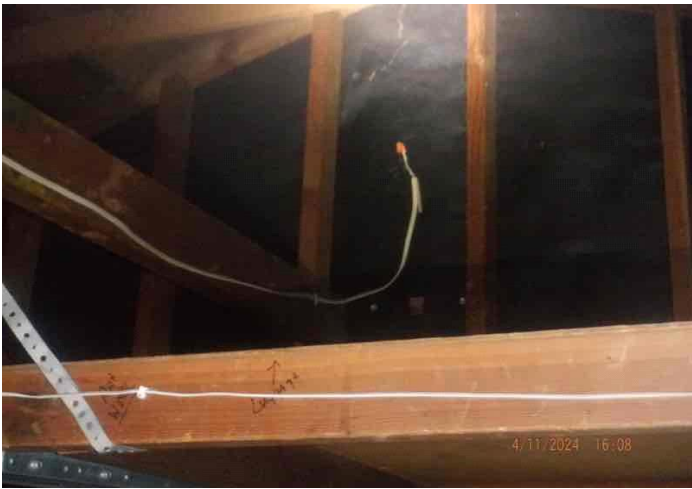
Photo 21

17. Abandoned wiring was noted in the front of the garage. We recommend the wiring be disconnected at its source or terminated in an approved manner in a covered junction box. (See Photo 21)

- ! 6. Abandoned wiring was noted in the front of the garage. We recommend the wiring be disconnected at its source or terminated in an approved manner in a covered junction box. (See Photo 21)

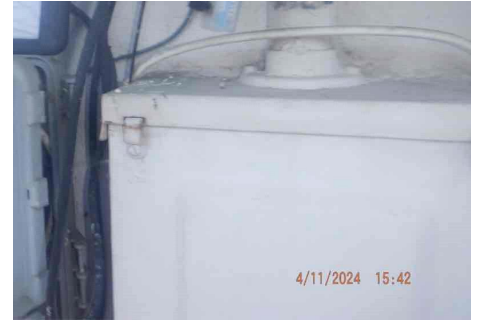
Photo 09

19. The main electric panel weatherproof cover plate is loose, damaged. We recommend it be repaired or replaced. (See Photo 9)

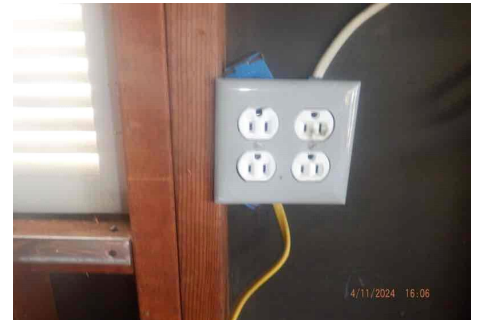
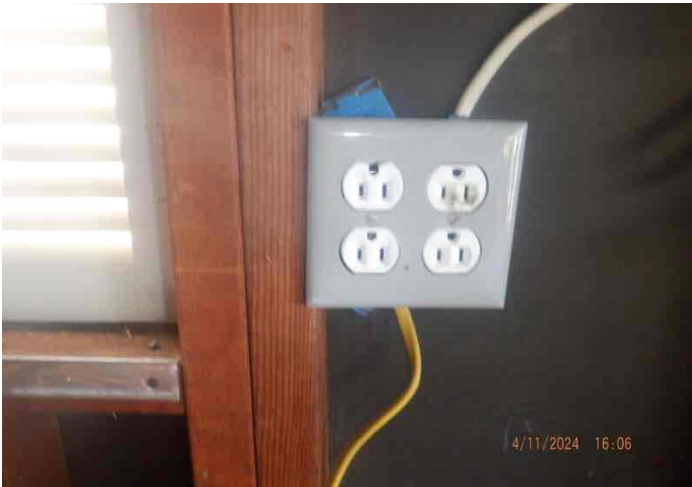
Photo 19

20. A receptacle at the right side of the master shows signs of scorching and overheating. We recommend this receptacle and the circuit connected to it be further evaluated by a licensed electrical contractor. (See Photo 19)

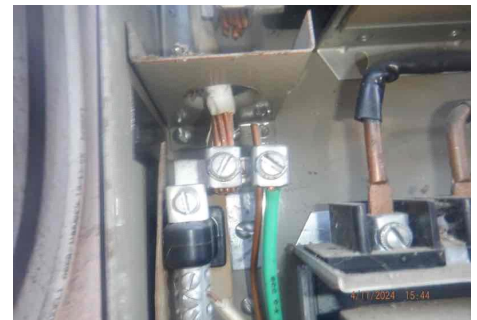
Photo 11

21. The electrical system grounding wire is improperly bonded. We recommend the panel be further evaluated by a licensed electrician and repaired or replaced as necessary. (See Photo 11)

- ! 11. The electrical system grounding wire is improperly bonded. We recommend the panel be further evaluated by a licensed electrician and repaired or replaced as necessary. (See Photo 11)

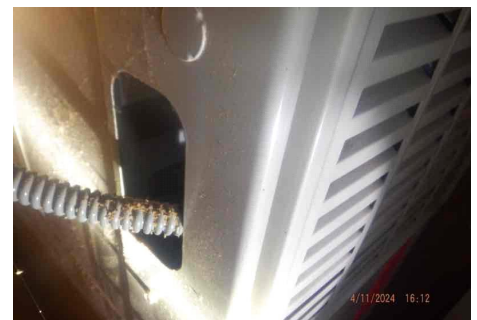
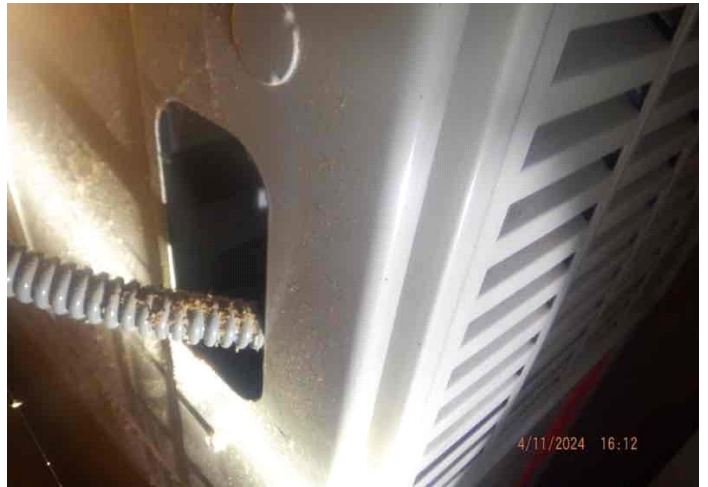
Photo 24

22. We noted a flexible gas line running through the furnace metal housing. We recommend consideration be given to installing rigid piping at the penetration of the housing and the installation of flexible supply piping at the exterior of the furnace. (See Photo 24)

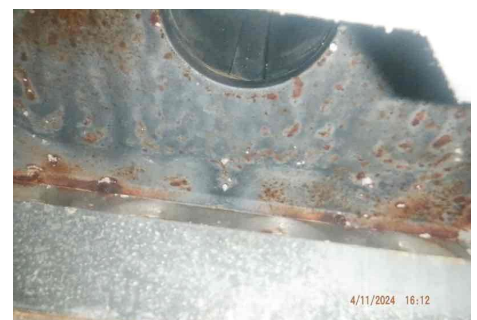
Photo 25

23. The heat exchanger is rusted, streaked and worn where visible from the exterior. These conditions indicate that it is at or near the end of its service life. We recommend inspections of the unit by the local utility company or a licensed heating contractor, to determine if repairs or replacement is necessary. (See Photo 25)

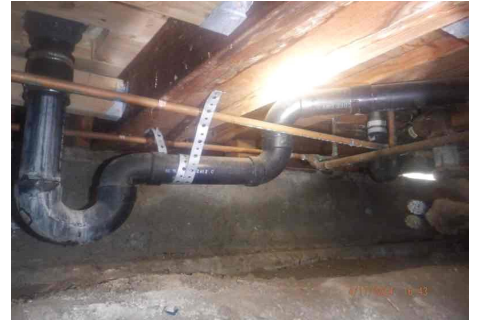
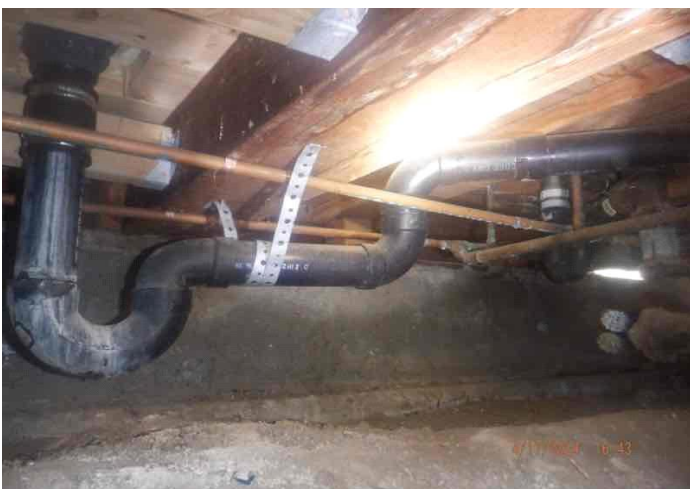
Photo 35

24. The drain system at the master bathroom was improperly installed. We recommend the drains be reconfigured according to industry standards. (See Photo 35)

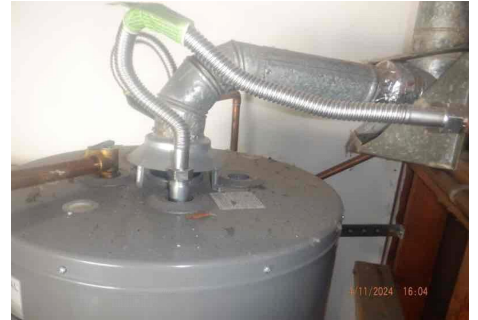
Photo 17

25. There is an insufficient upward slope on the water heater vent ducting. This can cause inadequate draft and exhaust spillage at the draft hood. This is a potential hazardous condition and should be repaired. (See Illustration 8T) (See Photo 17)

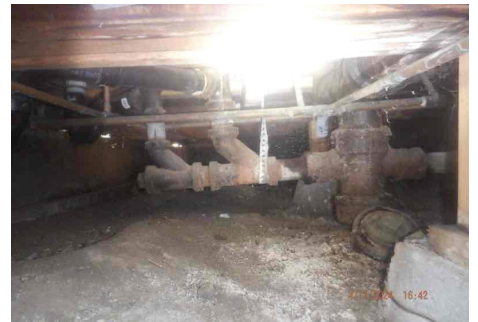
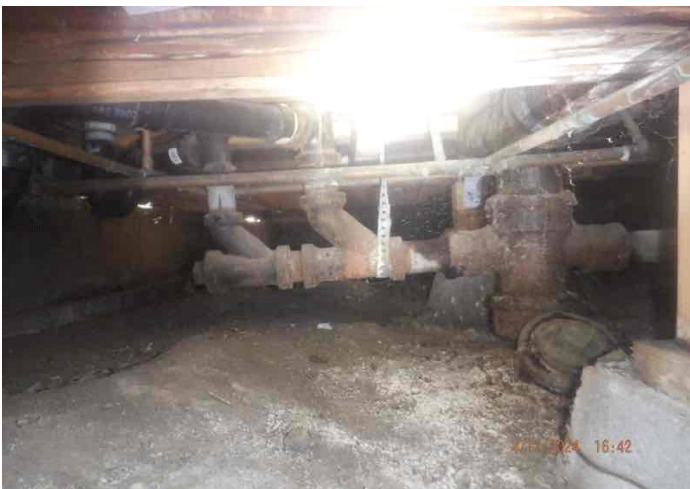
Photo 33

26. The waste piping at the crawlspace adjacent to the bathrooms does not have sufficient slope for proper drainage. We recommend this condition be corrected. (See Photo 33)

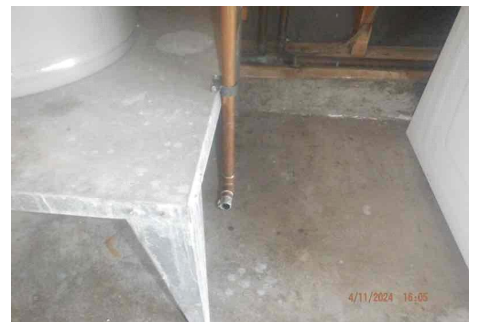
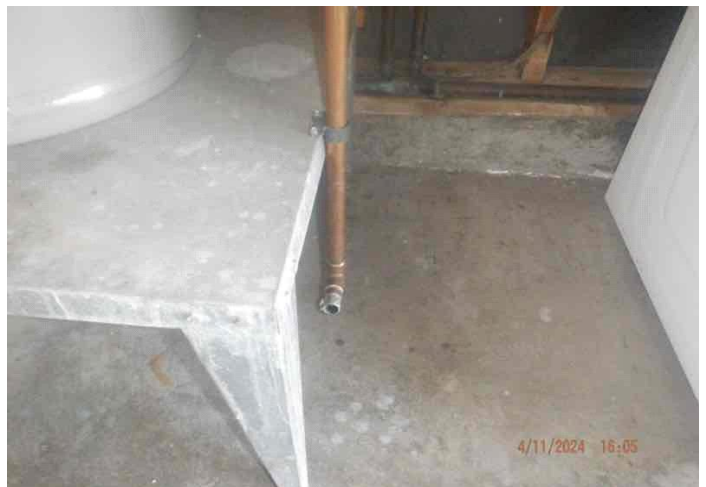
Photo 18

27. The temperature and pressure relief discharge pipe for the water heater is improper. We recommend the installation of a proper discharge pipe to an approved location. (See Photo 18)

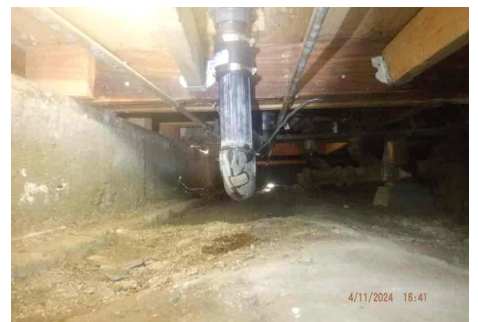
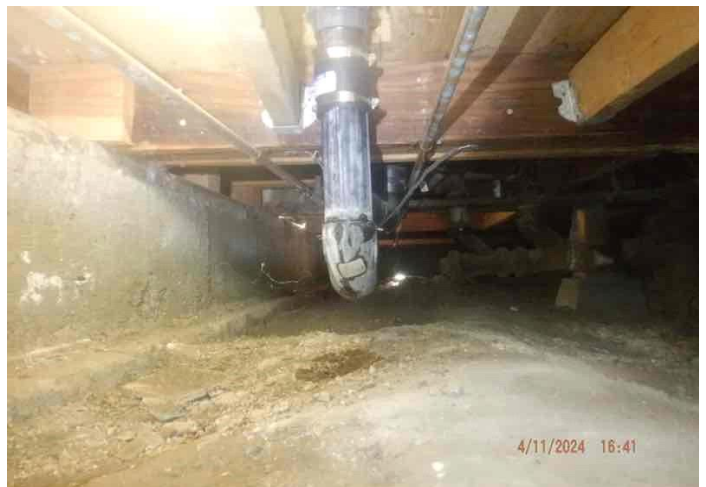
Photo 30

28. The drain is leaking into the crawl space under the master bathroom shower. We recommend all leaks be repaired. (See Photo 30)

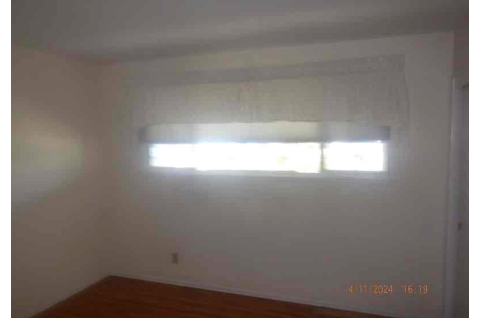
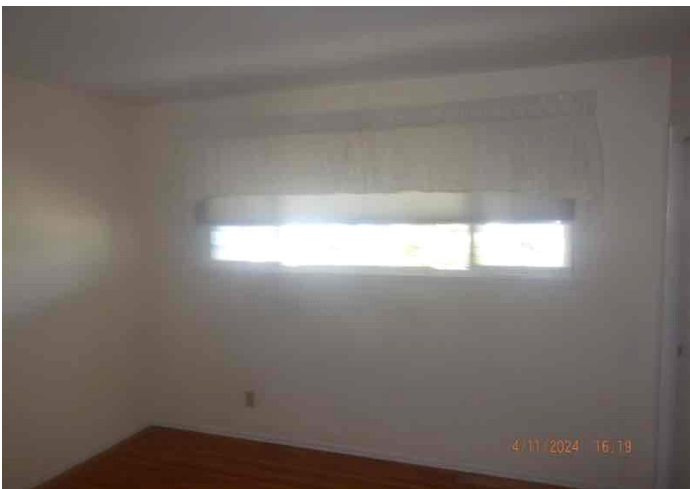
Photo 27

29. The height the windows in the front bedrooms does not conform to proper standards for egress. We recommend contacting the local building department to confirm if this installation conforms to specifications for escape openings in bedrooms. (See Photo 27)

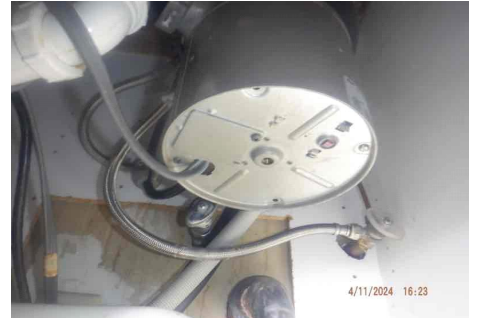
Photo 29

30. The power cord is not secured where it enters the bottom of the disposal and can be easily damaged. For maximum safety, we recommend the power cord be properly connected to the disposal. (See Illustration 9H) (See Photo 29)

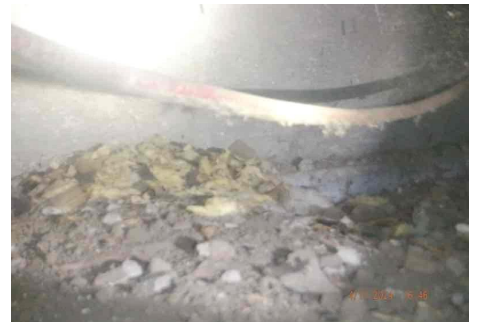
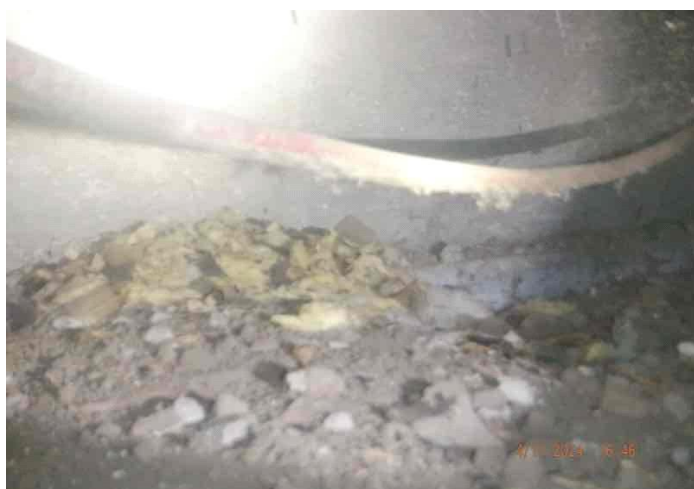
Photo 39

31. Evidence of vermin activity was observed within the structure. It is likely this evidence will extend into inaccessible areas. The owner is advised to contact the appropriate trade for further evaluation and remedial measures if necessary. (See Photo 39)

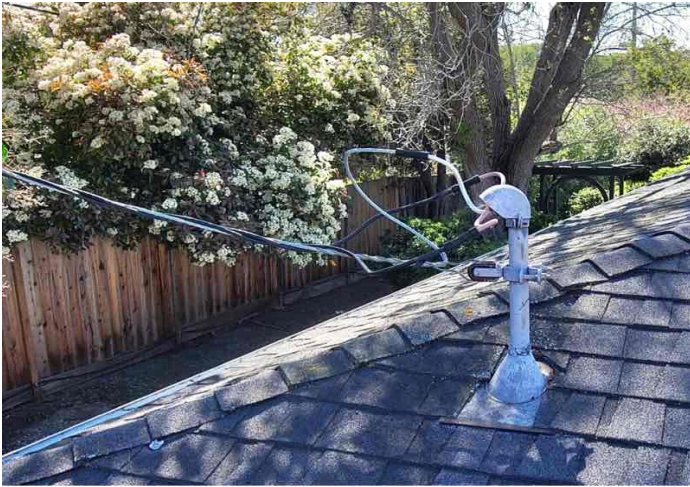
Photo 01

18. The service wires should form a drip loop where they meet the service mast on the exterior of the home. This will ensure that water will drip off the wires, rather than run into the service mast. This work should be done by, or coordinated with the local utility service provider. (See illustration 4P) (See Photo 1)

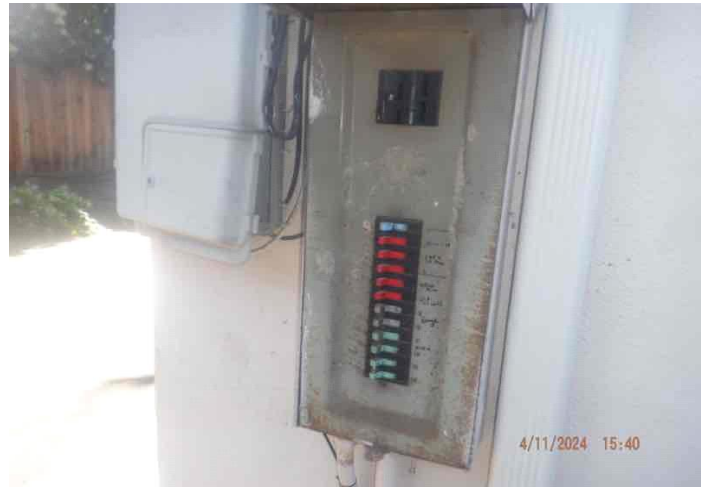
Photo 08

10. We have observed a "Zinsco/Sylvania" main electrical service panel(s) on the property. This type of panel has a history of circuit breakers failing to trip or overheating in response to an over current or short circuit. Failure of a circuit breaker to trip does not afford the protection that is intended and required. These brands have been obsolete for decades, and are a safety hazard. We recommend a licensed electrician be retained for additional information and recommendations. An electrician is likely to recommend full replacement of the panel. (See Photo 8)

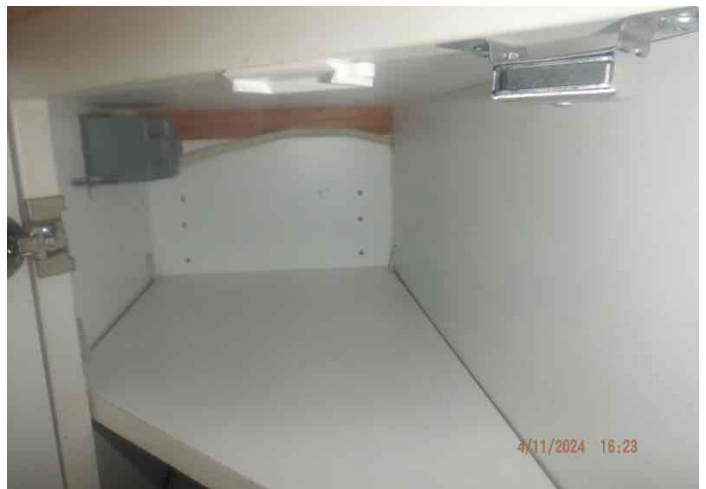
Photo 28

12. Exposed wiring inside the kitchen island cabinet should be relocated, covered or protected by rigid conduit. (See Photo 28)

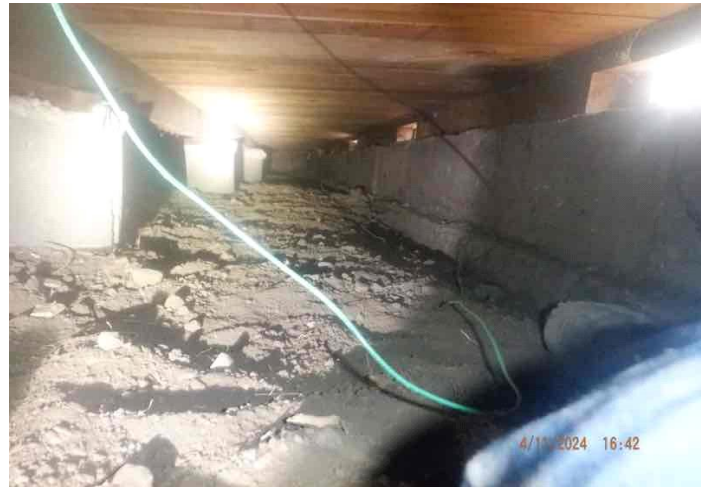
Photo 32

1. Loose wiring in the crawlspace should be corrected by securing it to the framing. (See Photo 32)
- ! 2. We found exposed wiring at the garage walls below 7' feet. Even if insulated, we recommend all wiring be encased in conduit or otherwise protected in accordance with present standards. (See Illustration 4E) (See Photo 16)
