## Home Inspection Report

**1064 Durham Court, Sunnyvale**

**Inspected by:**    
Andrew Amon  
April 11, 2024

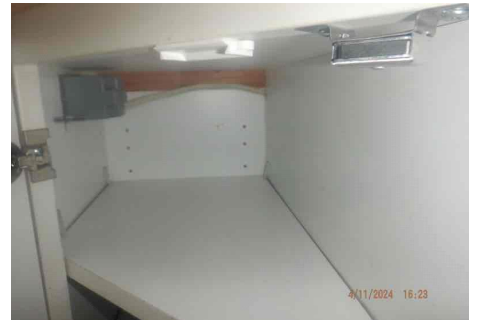
Photo 28

12. Exposed wiring inside the kitchen island cabinet should be relocated, covered or protected by rigid conduit. (See Photo 28)

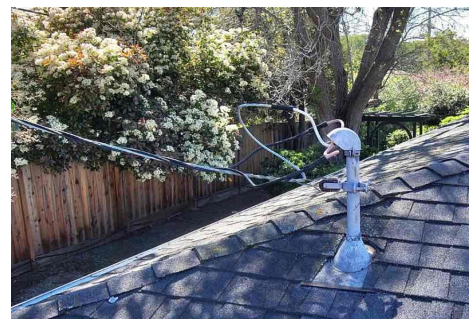
Photo 01

18. The service wires should form a drip loop where they meet the service mast on the exterior of the home. This will ensure that water will drip off the wires, rather than run into the service mast. This work should be done by, or coordinated with the local utility service provider. (See illustration 4P) (See Photo 1)

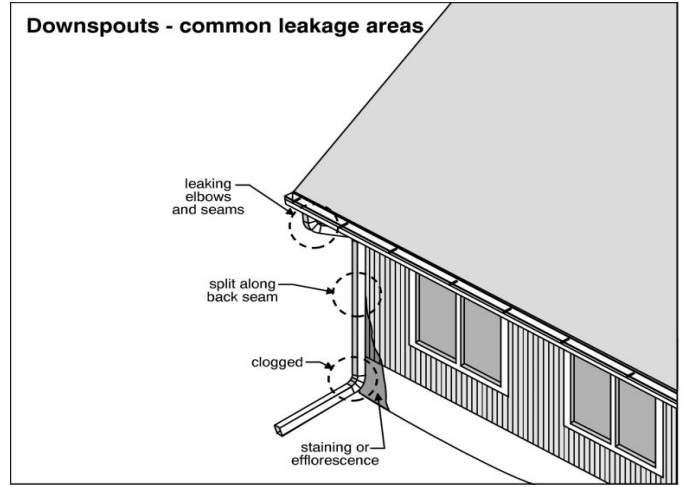
Illustration 2D

2. Leaks were noted in the downspouts and/or gutters at the seams. During wet weather conditions these areas are more obvious and during dry weather conditions they are noted from the stains at the areas where the leaks have occurred. We recommend all leaks be repaired. (See Illustration 2D) (See Photo 2)

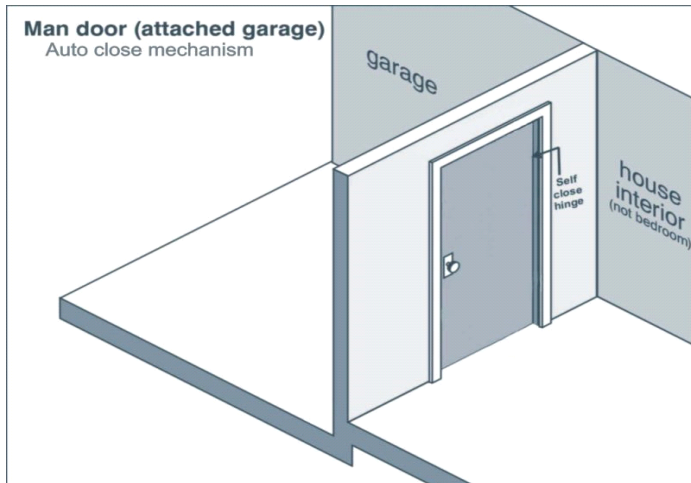
Illustration 3F

5. The auto door closer between the garage and the house did not function properly. The auto closer mechanism on the passage door between the garage and the interior of the house should be adjusted or repaired to close automatically. This will reduce the potential of toxic automobile gases entering the house and serves as a fire break. (See Illustration 3F) (See Photo 23)

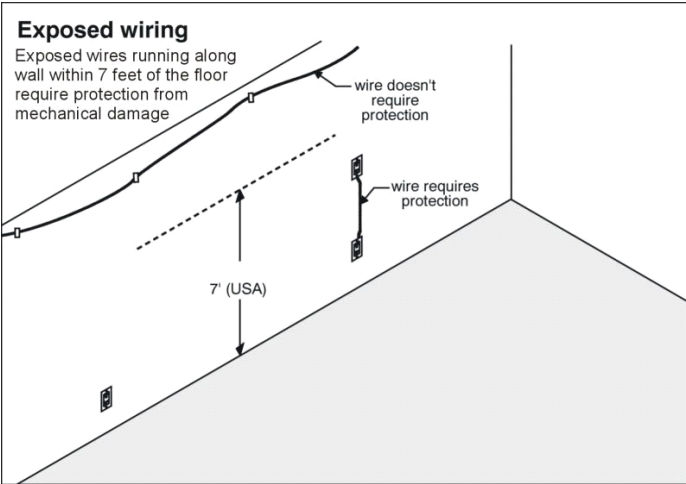
Illustration 4E

11. We found exposed wiring at the garage walls below 7' feet. Even if insulated, we recommend all wiring be encased in conduit or otherwise protected in accordance with present standards. (See Illustration 4E) (See Photo 16)

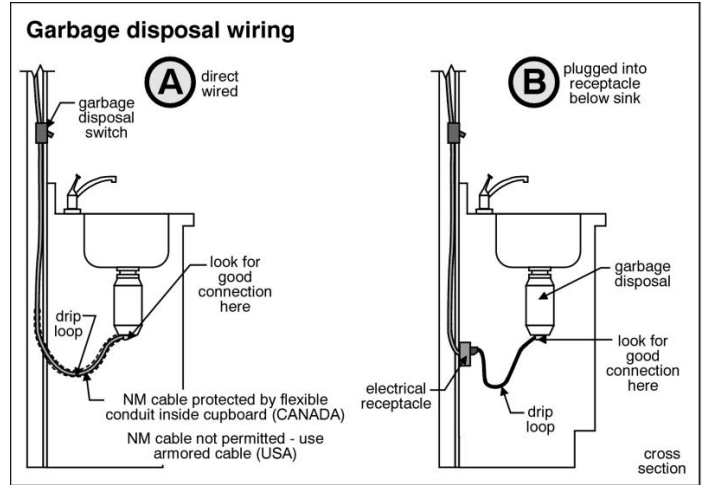
Illustration 9H

- ! 2. The power cord is not secured where it enters the bottom of the disposal and can be easily damaged. For maximum safety, we recommend the power cord be properly connected to the disposal. (See Illustration 9H) (See Photo 29)

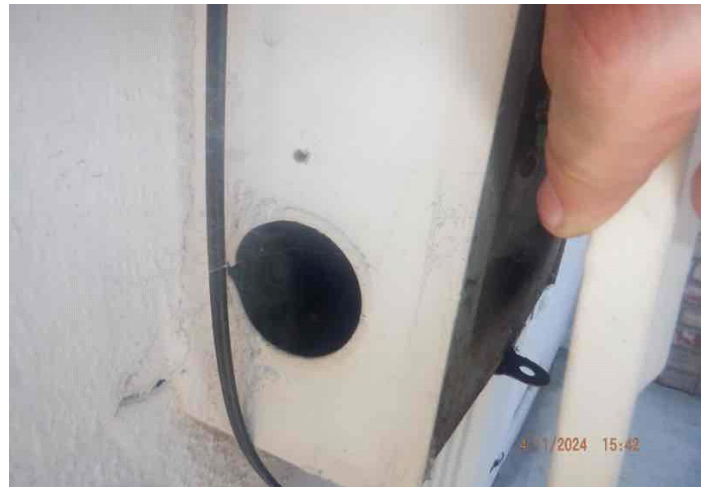
Photo 10

- ! 3. Any openings inside the main electrical panel or front cover "Dead Front" should be covered with approved filler plates or plugs. (See Illustration 4H below) (See Photo 10)

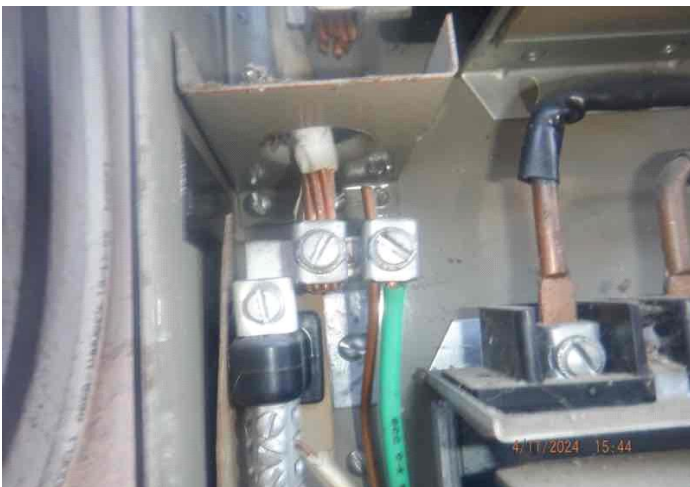
Photo 11

21. The electrical system grounding wire is improperly bonded. We recommend the panel be further evaluated by a licensed electrician and repaired or replaced as necessary. (See Photo 11)

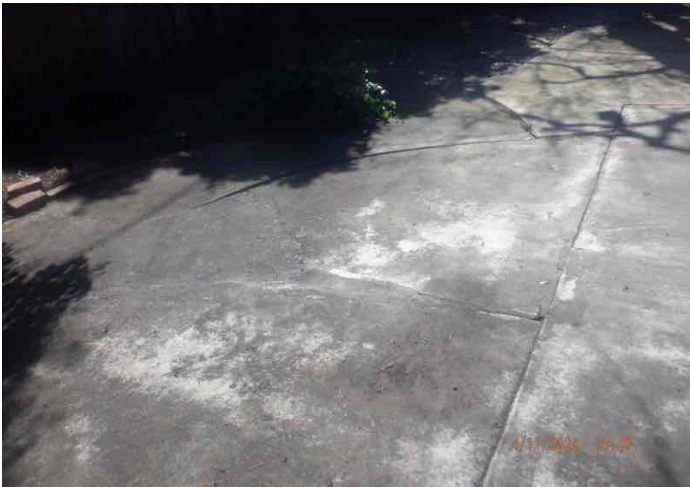
Photo 13

3. The cracked and heaved section of the patio presents a trip hazard. This condition should be corrected for improved safety. (See Photo 13)

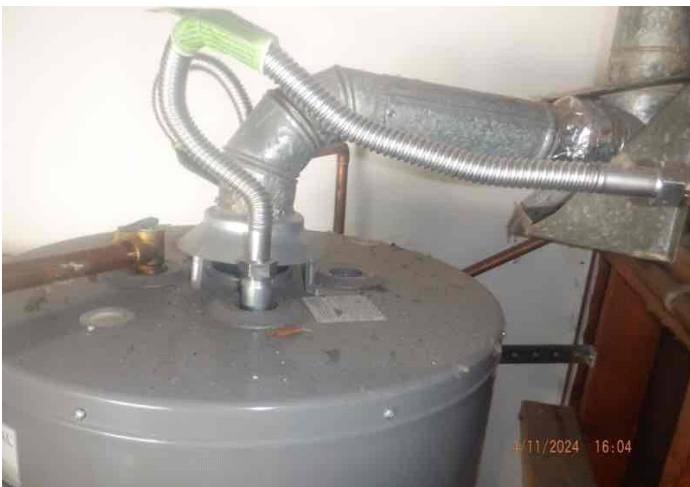
Photo 17

- ! 2. There is an insufficient upward slope on the water heater vent ducting. This can cause inadequate draft and exhaust spillage at the draft hood. This is a potential hazardous condition and should be repaired. (See Illustration 8T) (See Photo 17)

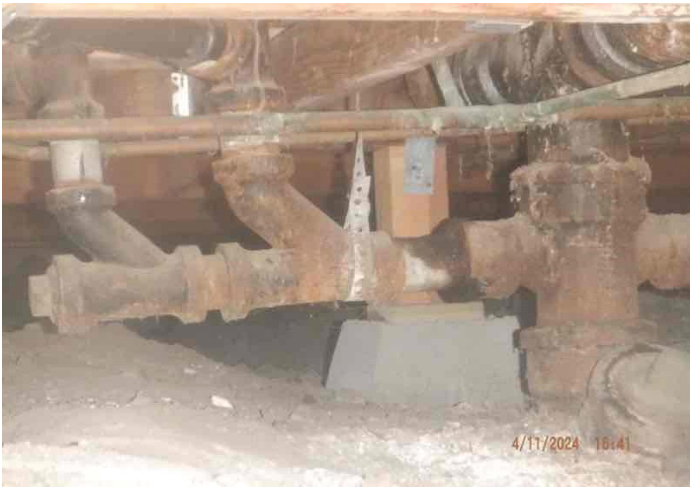
Photo 31

1. The metallic drain piping may be nearing the end of its effective service life. Older piping is subject to corrosion on the interior and/or exterior which may result in clogging and eventual leakage. We recommend the piping be further evaluated by a licensed plumbing contractor to determine if replacement or repair is necessary. (See Photo 31)

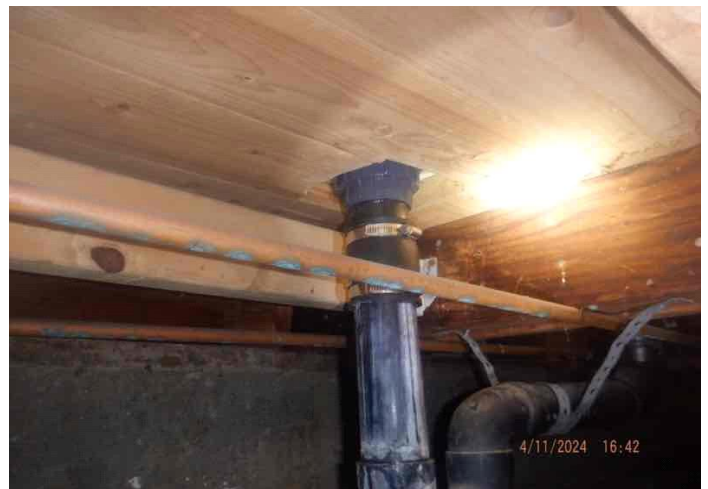
Photo 34

9. Improper materials and/or repairs were noted to the plumbing at the master bathroom shower. These repairs are not likely to last or be effective. The non-conforming material and/or repairs should be corrected. (See Photo 34)

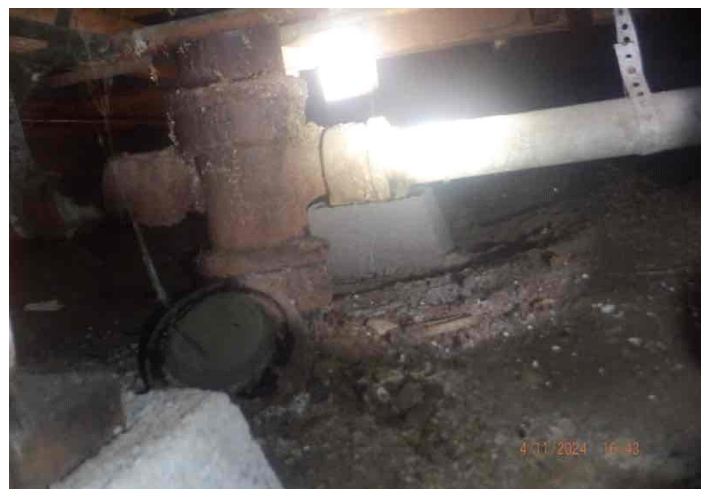
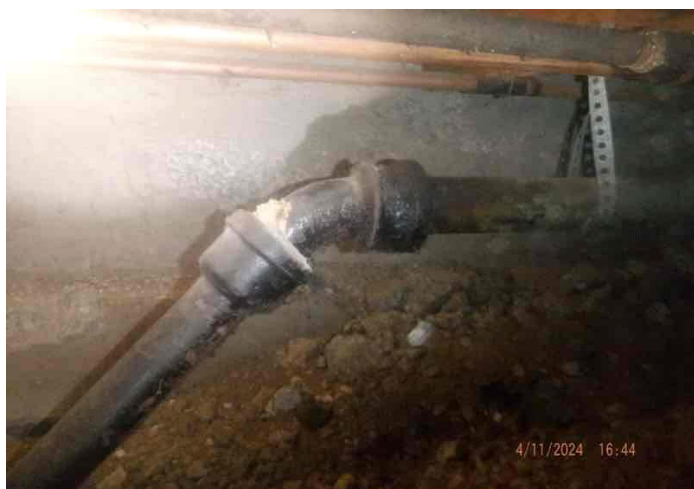
4. There is evidence of heavy corrosion and rust, but no leakage on the exposed and accessible metal drain piping at the crawl space. This piping should be monitored for leakage and repaired as necessary. Upgrading this piping and connections should be considered. (See Photo 37) (See Photo 36)
